HISTORIC SITES SURVEY FIELD SHEET  
Individual Structure Survey Form

COUNTY: Anne Arundel		SURVEY NUMBER: AA 517	
TOWN: Annapolis		NEGATIVE FILE NUMBER:	
LOCATION: 183 Green Street		UTM REFERENCES: Zone/Easting/Northing	
COMMON NAME:		U.S.G.S. QUAD. MAP:	
FUNCTIONAL TYPE: Res Map 32 Par 292		PRESENT FORMAL NAME:	
OWNER: Historic Annapolis, Inc.		ORIGINAL FORMAL NAME:	
ADDRESS: 194 Prince George St. Annapolis, MD 21401		PRESENT USE: Vacant	
ACCESSIBILITY TO PUBLIC: Yes (X) No ( ) Restricted ( )		ORIGINAL USE: SF Res	
LEVEL OF SIGNIFICANCE: Nat. Reg. ( ) Local (X) State ( ) National (*)		ARCHITECT/ENGINEER:	
GENERAL DESCRIPTION:		BUILDER/CONTRACTOR:	
Structural System		PHYSICAL CONDITION OF STRUCTURE:

1. STATE <u>Annapolis, Maryland</u> COUNTY _____ TOWN _____ VICINITY _____ STREET NO. <u>183 Green Street</u>		HISTORIC AMERICAN BUILDINGS SURVEY INVENTORY	
ORIGINAL OWNER _____ ORIGINAL USE <u>residence</u> PRESENT OWNER <u>Dorothy Strickland</u> PRESENT USE <u>residence (vacant)</u> WALL CONSTRUCTION <u>brick/clapboard</u> NO. OF STORIES <u>two plus dormer attic</u>		2. NAME <u>Brewer House</u>  DATE OR PERIOD <u>c. 1740</u> STYLE <u>Georgian</u> ARCHITECT _____ BUILDER _____

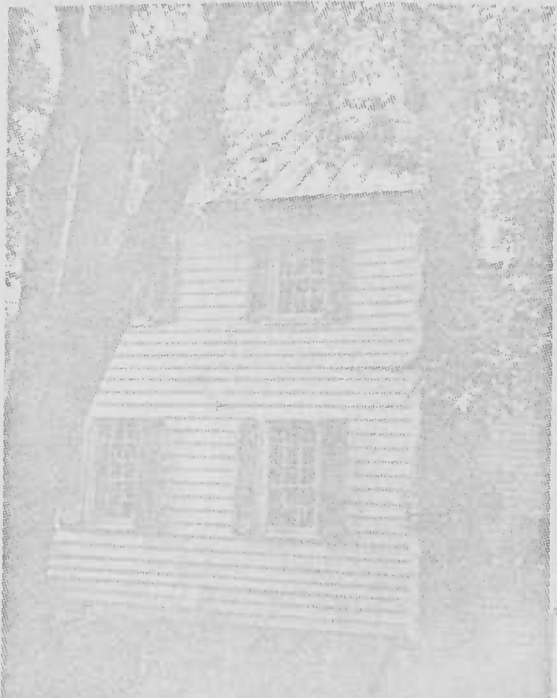
4. NOTABLE FEATURES, HISTORICAL SIGNIFICANCE AND DESCRIPTION		3. FOR LIBRARY OF CONGRESS USE	
OPEN TO PUBLIC <u>no</u>		Set back from Green Street and hidden by massive foliage is an outstanding example of colonial American architecture. The house is almost totally unaltered except for 1st storey windows in front and porch addition. Three walls are wide, overlapping clapboard, the other, an end wall in English bond brick, including a massive chimney. The roof is of steep pitch with a 6/6 dormer on each side. There is a simple wood cornice. Three 2nd storey front windows are 6/6. Rear of house is very fine with original window sash, 6/6 on 2nd storey, 9/6 on 1st storey. House is raised up on c. 3' brick base. House has good deal of land for town house. Exterior restoration would be minimal and age, historical associations, and architectural significance make its preservation and maintenance an absolute must! (Also known as Iron Master's House.)

5. PHYSICAL CONDITION OF STRUCTURE

good		6. LOCATION MAP (Plan Optional)	
7. PUBLISHED SOURCES (Author, Title, Pages) INTERVIEWS, RECORDS, PHOTOS, ETC.  <u>Historic Annapolis, Inc.</u> <u>Orlando Ridout IV</u>  <u>Connection H.A. Inc 18767</u>		8. NAME, ADDRESS AND TITLE OF RECORDER  <u>William D. Morgan</u> <u>Columbia University</u> <u>New York City</u>  DATE OF RECORD <u>July 19, 1967</u>

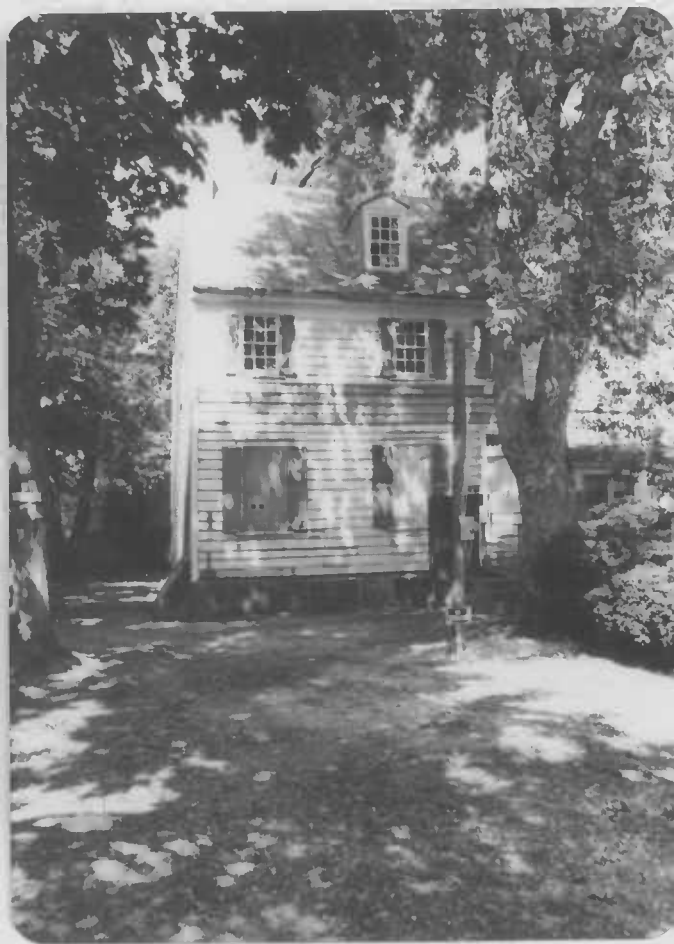
SE Elevation/camera facing NW

Gabled dormer, boxed cornice, beaded weatherboards, brick end wall with chimney (new); molded window and transom lit door caps; entrance porch to be added-under restoration.
